Investigation of a 1-Ton Tank-Car Tank That Leaked Phosgene in Easton, Pennsylvania on April 24, 1973

C. G. Interrante

April 1975

Failure Analysis Report

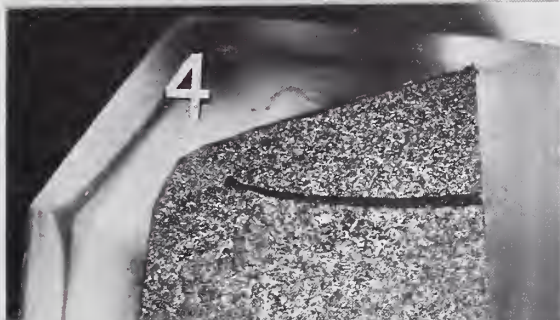
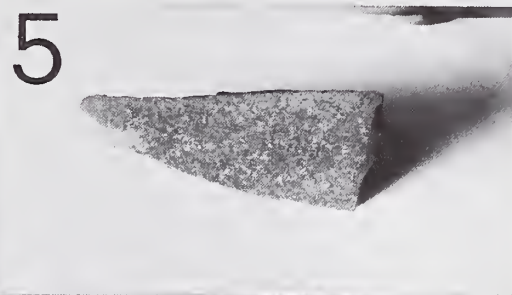
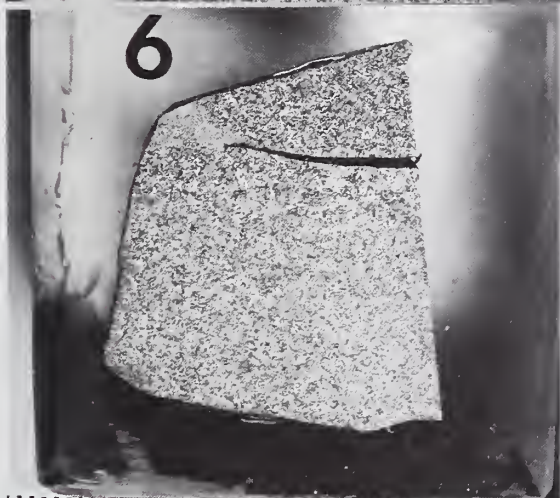
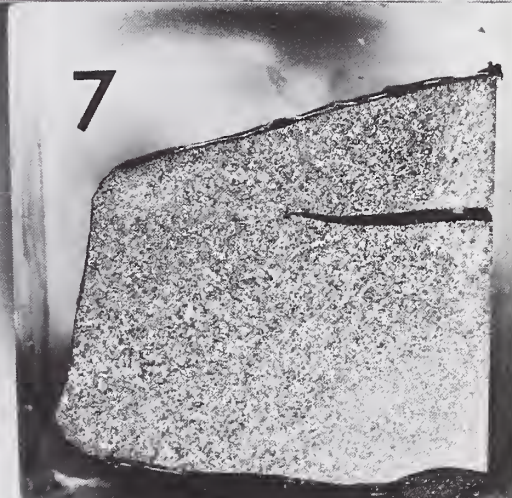
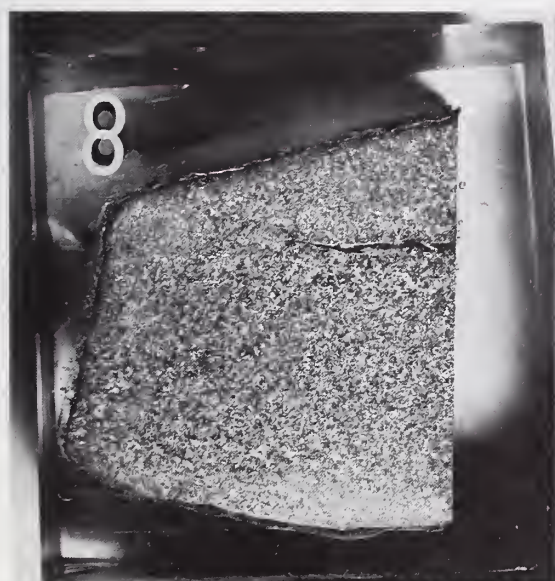
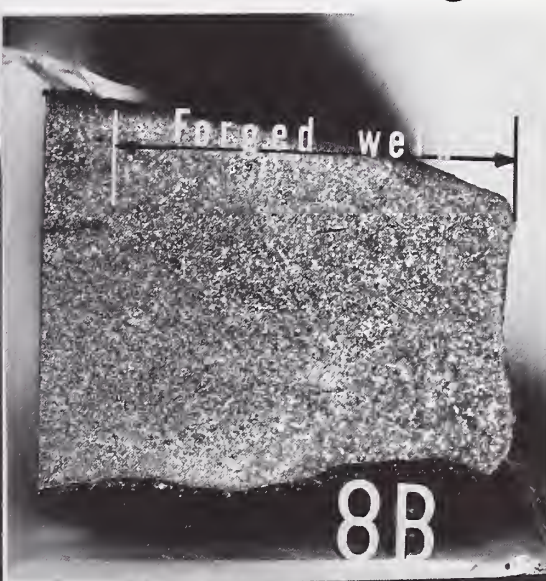
Both the rough-ground segments of Figure 4 and the polished segments of Figure 5 show that the bonded region extends for less than 0.4 inches (1.0 cm), in segments numbered 1 through 7, and for about 0.6 inches (1.5 cm), in segment number 8. The shortness of these lengths of the bond line are somewhat surprising, especially for segments 2, 4, and 5 which have bond line lengths of less than 0.2 inches (0.5 cm).

In the polished and etched condition (Figure 5), segments numbered 2, 4, and 5 were observed to have no fusion from lap welding, i.e. no forged weld region. The bonded metal shown here for these three segments is that of a tac weld at the end of the vessel. The other segments examined had at least some small length of forged weld metal along their bond lines. Segments 1B and 8B were taken from the ends of the original flame-cut section at distances somewhat remote from the leak, as marked on the photograph of Figure 2. In Figure 5, the polished and etched faces of these two segments clearly show forged weld metal in lengths of 1.3 inches (3.3 cm) for 8B and 0.6 inches (1.5 cm) for 1B. Segment 8B is more distant from the tac weld than any of the other segments examined, and 8B has the longest forged weld region.

Figure 5. Eight 1-inch segments from near the leak and two end segments taken from the section that contained the leak, in the cropped, polished, and etched condition.
